ARSENIC & OLD LAND

Alan Halperin, P.G. D'Appolonia Engineering
Thomas Willard, CHMM Core Compliance Group

Oakmont is an affluent riverfront community on Allegheny River, within 15 miles of downtown Pittsburgh. Not a typical Southwestern PA Milltown, Oakmont has PGA Tour stop at Oakmont Country Club, but also had local steel mill, 57 acre site of electric arc furnaces until 2002 .

**Southern 23 ac. portion of millsite
is focus of this study**

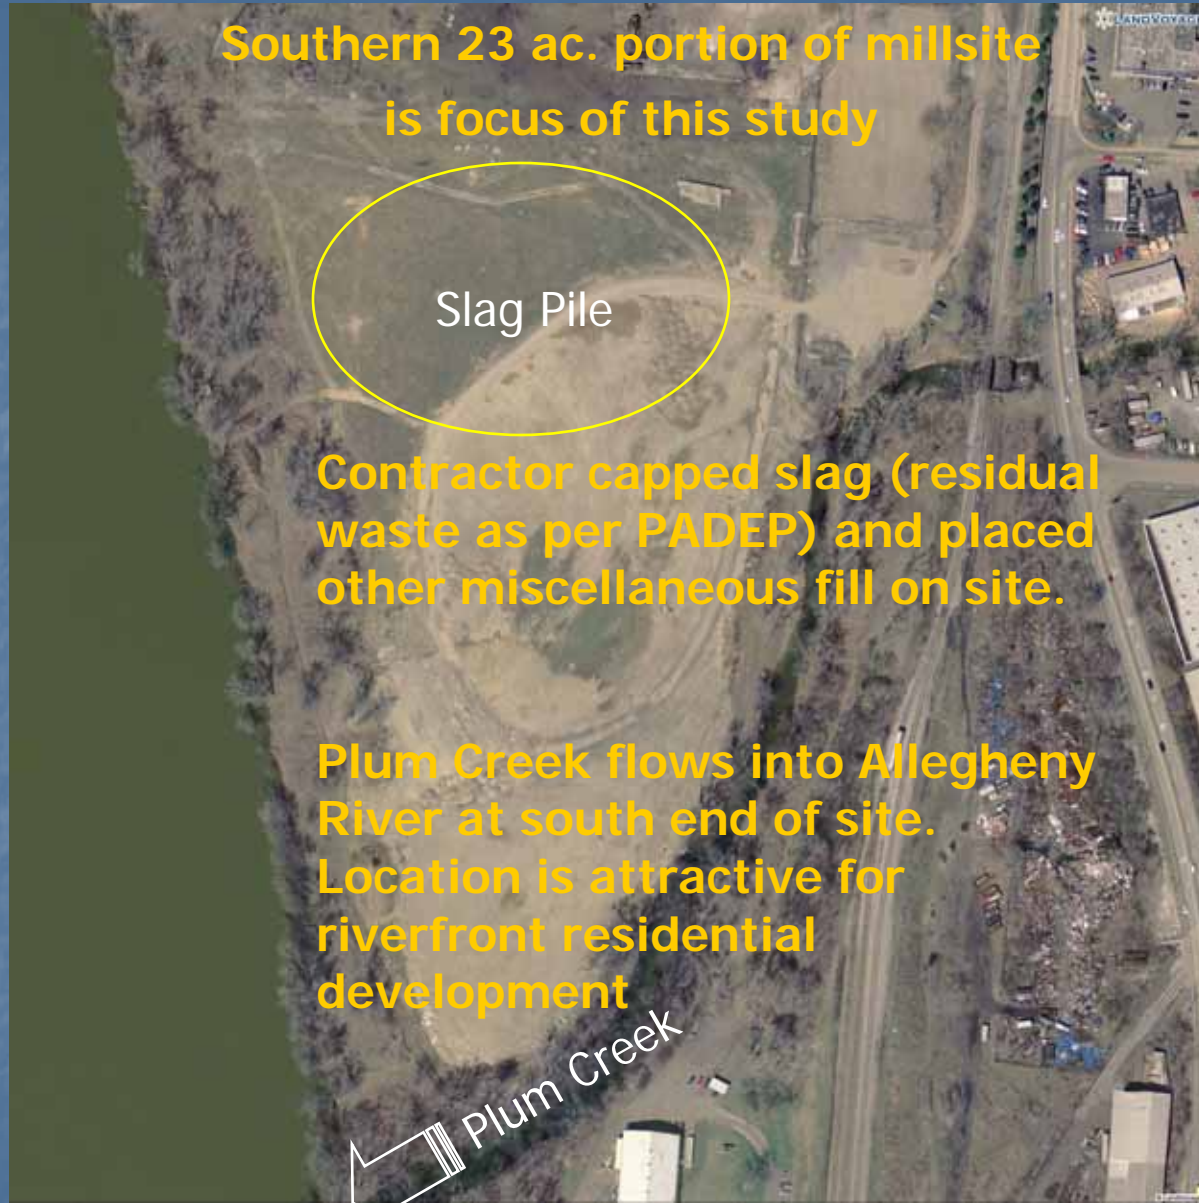
DRAWING NUMBER 041183-M1
 CHECKED BY
 APPROVED BY
 DRAWN BY
 DATE 2/23/05

Slag Pile

**Contractor capped slag (residual
waste as per PADEP) and placed
other miscellaneous fill on site.**

**Plum Creek flows into Allegheny
River at south end of site.
Location is attractive for
riverfront residential
development**

Plum Creek

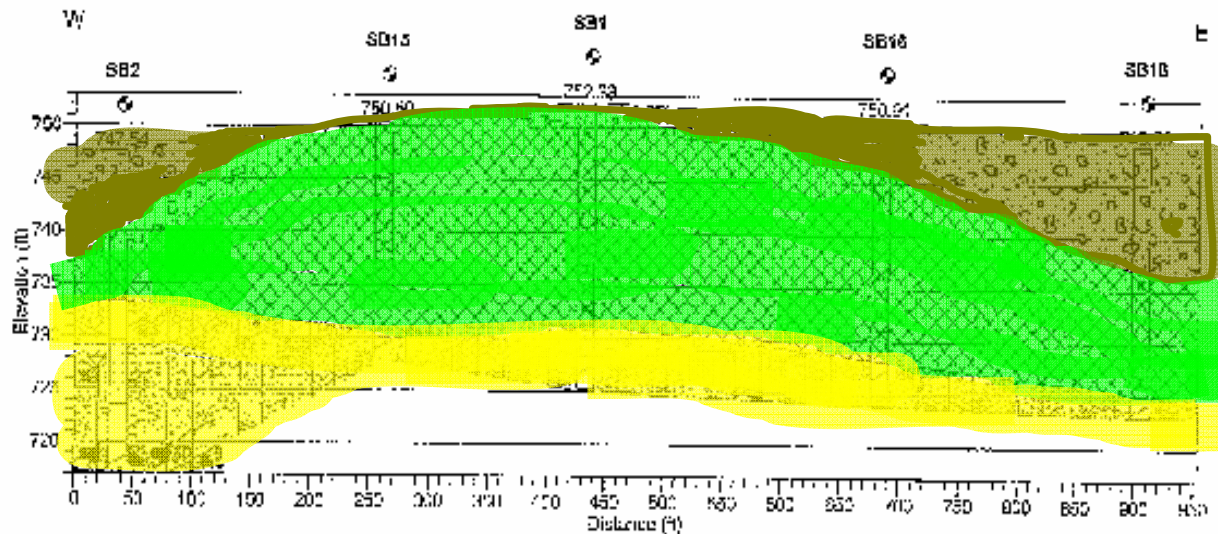
Cross section perpendicular to river. Slag pile occurs beneath miscellaneous fill cap. All fill underlain by alluvium.

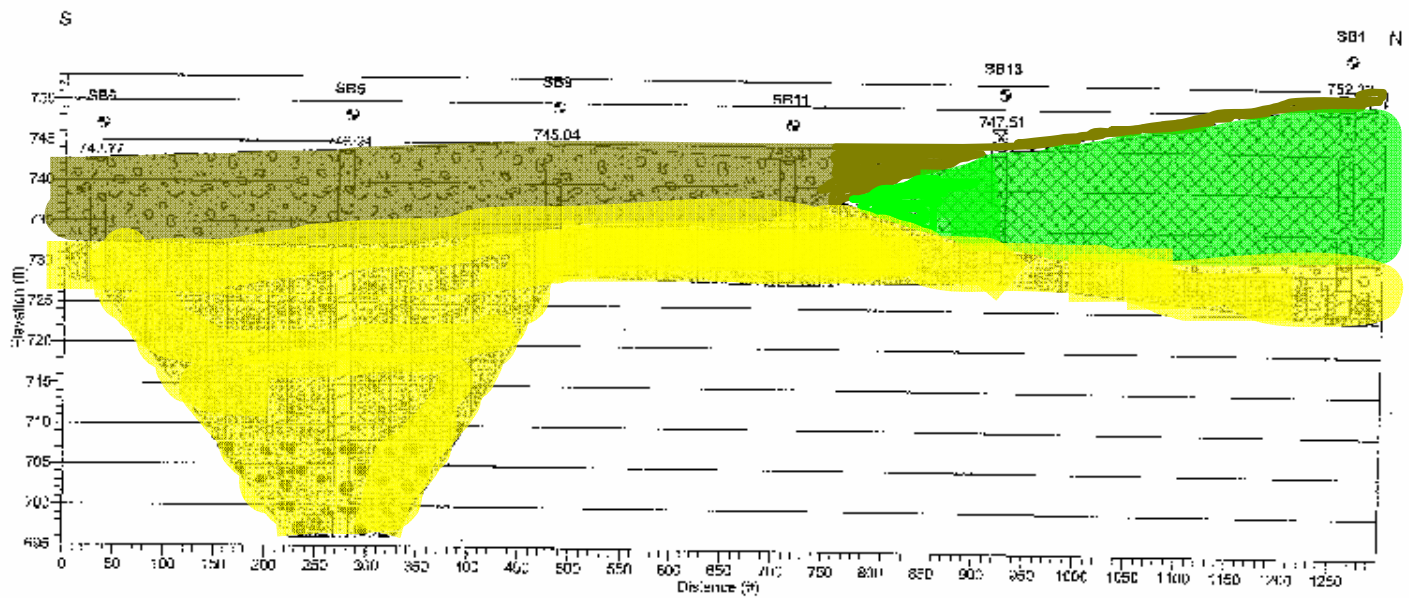
Cross section parallel to river. Slag pile to north.
